Court of Appeal
Supreme Court
New South Wales

Case Name: Owners of Strata Plan No 30791 v Southern Cross Constructions (ACT) Pty Ltd (in liquidation)

Medium Neutral Citation: [2020] NSWCA 199

In 2010, building works on a development project led to movements of the foundation strata below an uphill adjoining property (**the Affected Property**), causing extensive damage to an apartment building situated on the Affected Property. The owners' corporation from the damaged building commenced proceedings against a variety of engineers, construction contractors and other parties connected to the development, but many of those claims settled. Proceedings continued against Southern Cross Constructions (**the Builder**) and Hughes Truman (**Hughes**), a structural engineering firm.

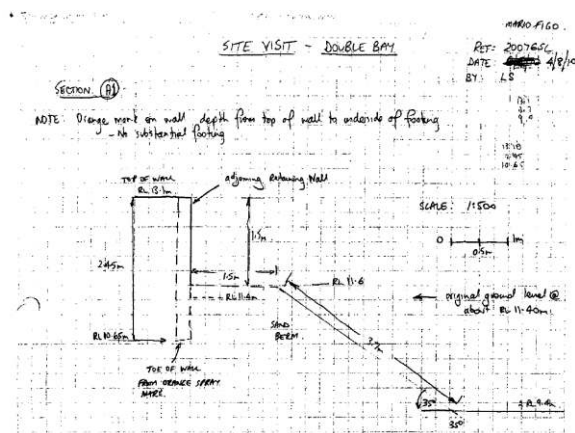
54 A cross-sectional drawing made by Mr Speechley on 4 August 2010 illustrates the effect of the proposed excavation as set out below:

The 35 degree toe of the berm is visible in the bottom right (at the excavated depth of RL9.4 m), the berm then slopes up for 3.7 m to RL11.6 m, before flattening to form a crest that then extends for 1.5 m to the Retaining Wall, which is on the left hand side of the drawing (the top of the Retaining Wall being RL13.1 m and the “toe” of the Retaining Wall being RL10.65 m). At certain points (generally where the Shoring Wall and Retaining Wall were closer together) the Shoring Wall would run through the slope of the berm, as indicated in a further sketch from 4 August 2010, which indicates the “approximate inside line of proposed piling” (as at that particular section). The sketch is as follows:

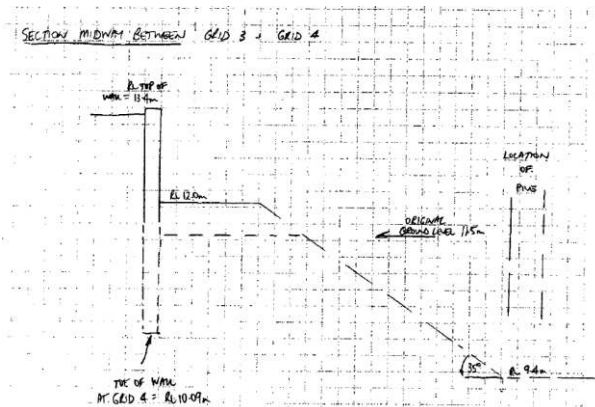
- 57 The email said that it had been agreed on site that the top of the capping beam must be raised to not lower than RL11.1 m for the section of the Shoring Wall

from the extreme northern end (encompassing the Northern Light Well) and including the Northern Return Wall. To the south of those sections of the Shoring Wall, the top of the capping beam could be dropped down to the original RL9.2 m. In those parts of the Shoring Wall, as shown in the following sketch, the piles for the Shoring Wall did not appear to interfere with the berm as, in those sections, the distance between the Shoring Wall and the Retaining Wall was greater:⁹

- 58 Mr Speechley also said in his email of 4 August 2010 that, over the section of the berm where the capping beam was to be placed at “RL11.1 m”, it would be necessary to increase the size of the berm to accommodate the piling equipment. He recommended that, during reformation of the berm, the top of the berm not be taken deeper than RL11.5 m, which was equivalent to the original ground level plus some allowance for the loosening of the upper sands. Mr Speechley also said that the berm must have a crest of not less than 3 m, although it was expected that that would be much wider to accommodate the piling rig safely. The email said that the berm must also have a batter slope not steeper than 1V:2H. Mr Speechley recommended that, over the section of berm where the capping beam was to be placed at RL9.2m, the berm be maintained as per its current configuration.

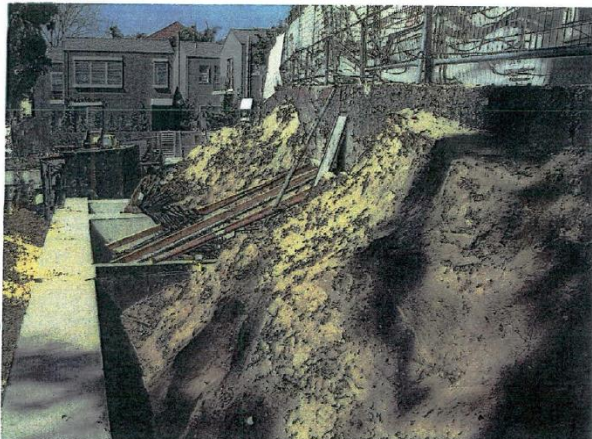
The irregular sand berm against the Retaining Wall, and the Temporary Retaining Propping (see below at [84]) above the Northern Light Well, is depicted in a photo taken by Mr Speechley during his site visit on 8 September 2010. The photo, which looks to the south, is set out below:

- The current berm supporting the Shoring Wall was not in accordance with the recommendations set out in J&K's email of 4 August 2010. The berm must be modified to have a batter slope not steeper than 1V:2H (that is to say about 26 to 27 degrees). The toe of the current berm was also lower than was assumed in J&K's wall analysis and had to be raised as soon as possible to RL6.6 m. For the very short-term temporary case, the level of RL5.9 m could be maintained until the Lateral Loading Piles supporting the new struts were constructed. However, the level must be raised back to not lower than RL6.6 m immediately after those piles being constructed. That was on the assumption that the berm was kept at not steeper than 1V:2H as discussed above.

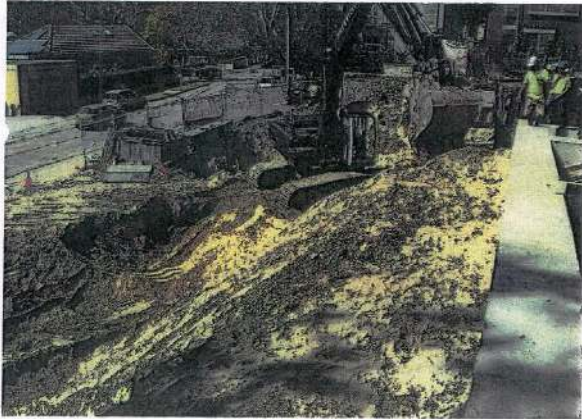
A part of the berm against the Shoring Wall is depicted in the photo of the same date set out below, where the capping beam at RL11.1 m is visible in the right-hand side, with Manning Road on the left:

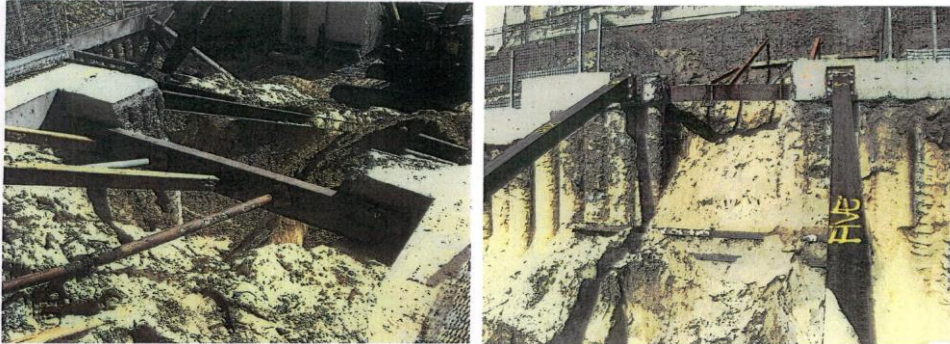
93 Mr Speechley took further images during his site visit. The two images set out below show the Northern Light Well after having the capping beam partially removed and the Shoring Wall piles having been cut down. The top of the

waler beam is visible in the right-hand image, which is the partially buried horizontal beam between the piles:

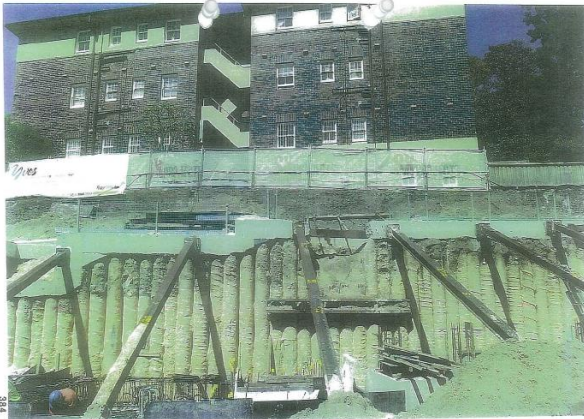
Figure J: Waler Beam Visible Following Excavation to Level 0 with Foundation Piles Visible Below Shoring Props

A fully excavated image taken on 16 November 2010 is set out at **Appendix 1, figure J.**
